Cedar Pole NEWS

Largest Montana Coop Uses Cedar Poles for 70 Years

Glacier Electric Coop Designs High Wind Storm Resistant Lines

The Hardening of Utility Lines -- Implications for Utility Poles Design and Use

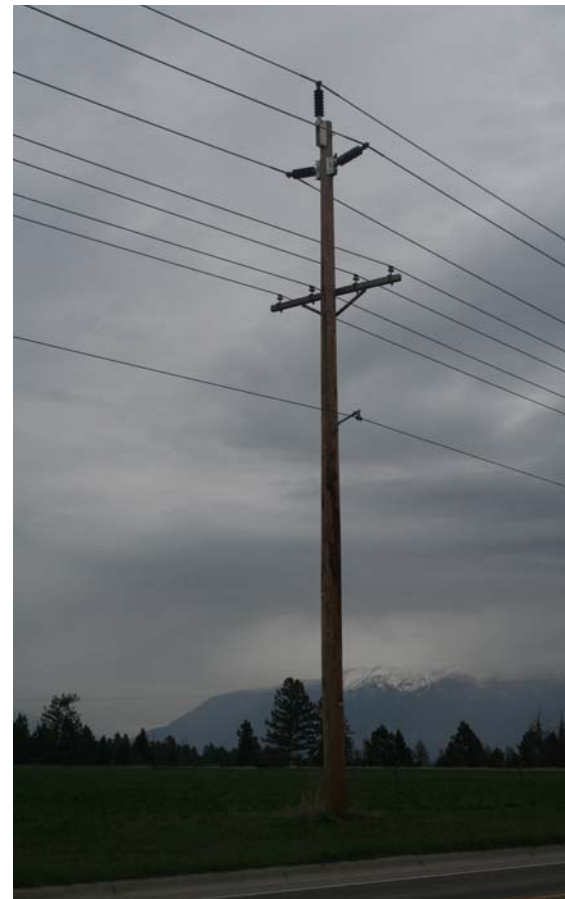
A typical Flathead Electric line, this line carries 34.5kV transmission at the top, 17.2kV distribution in the middle and cable below. A recently rebuilt line, these cedar poles are 55 ft. Class 1, full-length, penta treated.

With 80,000 poles in service, Flathead Electric Coop uses Class 5 and 6 cedar poles for distribution lines and up to 85 ft. H1 and H2 cedar poles for transmission lines.

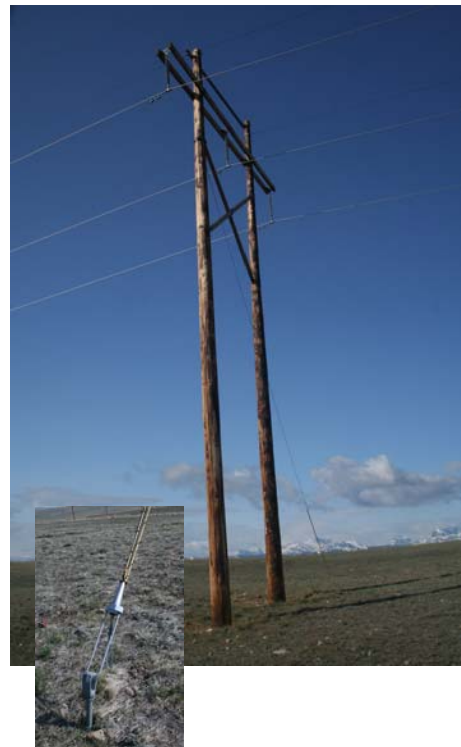
Sustained high winds in the Glacier Electric system can cause vibration that “walks” a pole structure out of the ground. The utility solved this potential problem by guying H-frame structures at right angles to the line direction. The cedar poles in this line are 70 ft. Class 2.

Glacier Electric uses side storm guy wires to assist poles from “walking out of the ground” due to the high winds. The pole foot mechanism placed at the bottom of the pole is the main device to keep the pole from “walking out.” The guy wire is a storm guy to keep the structure from leaning and reaching the “bending/breaking” moment during the high cross winds that come directly off

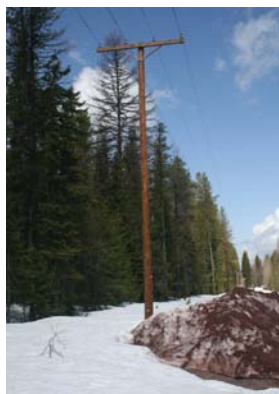
This 45 ft. cedar distribution pole carries 14.4kV power into the Rocky Mountains along Hwy 2.

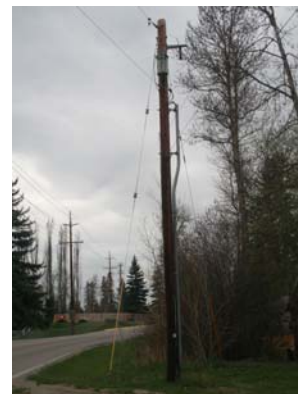
This a typical 35 ft. Class 5 cedar distribution pole used in the Flathead Electric system.
